SRI International

Annual Report No. 1 • October 1993

MICROSTRUCTURE/PROPERTY RELATIONSHIPS FOR SCS6/TIMETAL 21-S COMPOSITE

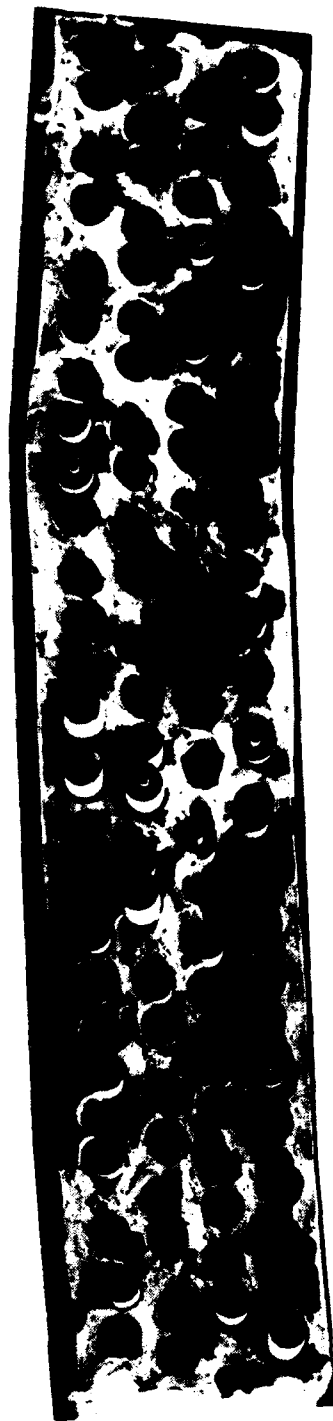
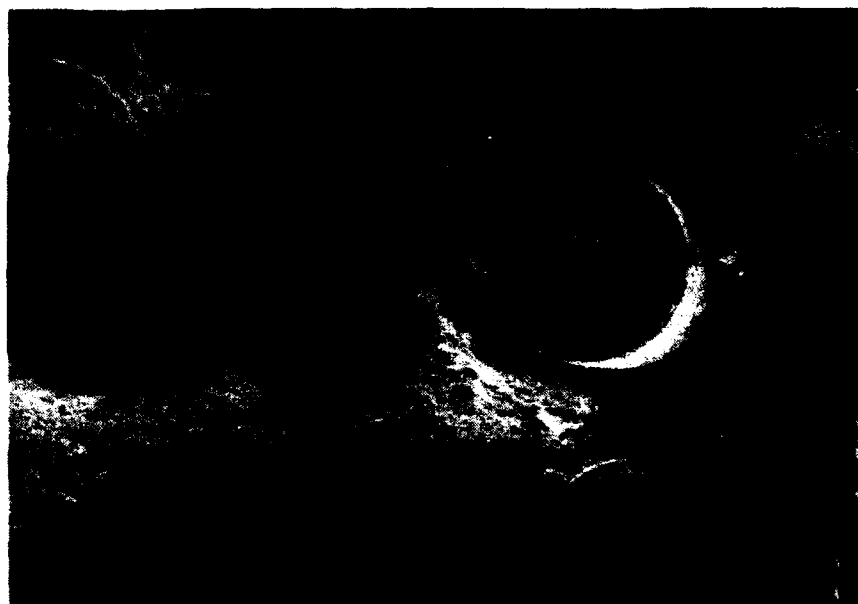
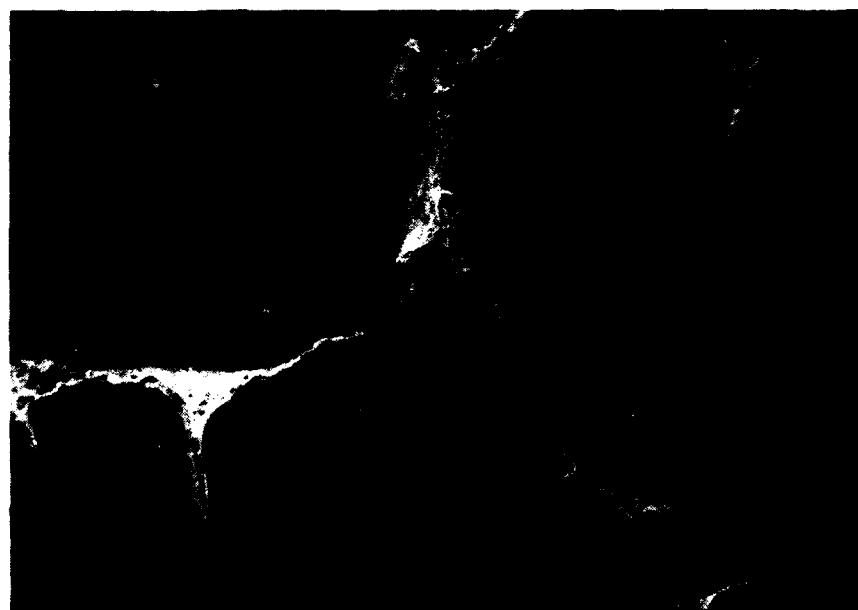
(a) Side A

(b) Side B

Figure 1. SEM micrographs of the fracture surfaces from the 23°C tensile test of Specimen 91-254.

(c) Orthogonal high magnification view of area on Side A

(d) Angled high magnification view of area on Side A

(e) High magnification view showing molybdenum fiber

Figures 1 and 2 show scanning electron microscope (SEM) micrographs of fracture surfaces from $[0]_4$ tensile specimens tested at 23° and 815°C, respectively. The fracture surface of the matrix component of the specimen tested at 23°C (Figure 2) exhibits the features of a material that failed in a ductile manner; however, in one of the composite plies, remnants of a wool fiber is clearly evident (see Figure 1e). Evidence of the fiber appears on both sides of the fracture surface. An X-ray energy dispersive spectrometer (EDS) analysis of the wool fiber indicated that its composition is high in molybdenum (see Table 2). The measured compositions of the matrix and the fiber are consistent with the nominal compositions of Timetal 21-S and SiC, respectively.

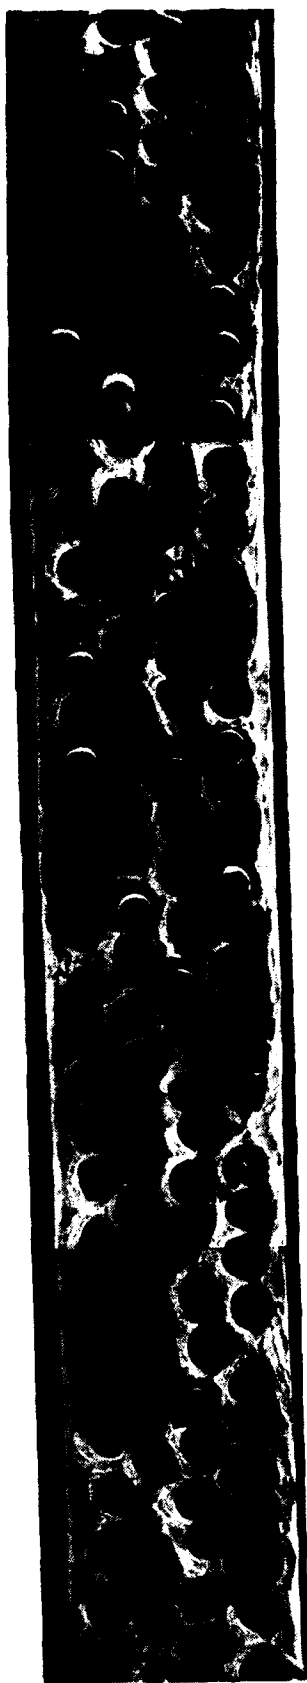
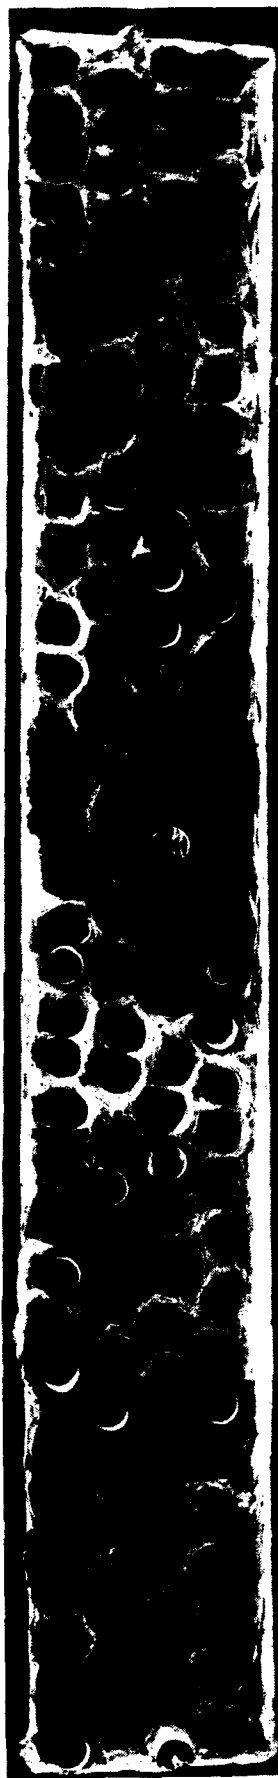
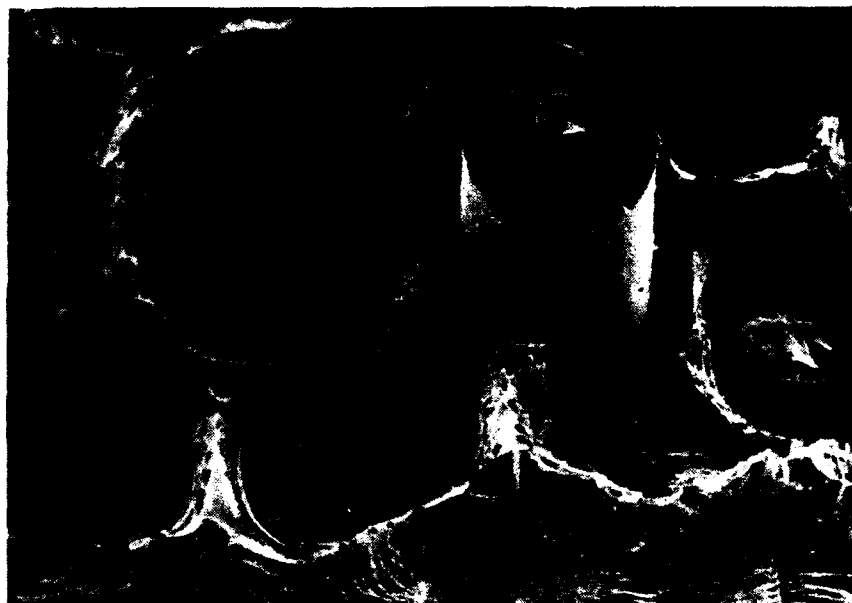
(a) Side A

(b) Side B

Figure 2. SEM micrographs of the fracture surfaces resulting from the 815°C tensile test of Specimen 91-247.

(c) Orthogonal high magnification view of area on Side A

(d) Angled high magnification view of area on Side A

The appearance of the matrix material on the fracture surface of the $[0]_4$ tensile specimen tested at 815°C shows greater ductility than the fracture surfaces from the 23°C test. To better compare the differences between the specimens tested at these two temperatures, a scanning laser microscope was used to topographically characterize representative regions of the fracture surfaces from tensile specimens tested at 23° and 815°C, as shown in Figure 3. Figure 4 compares the fracture surface profile of the matrix material between two fibers in 23° and 815°C test specimens. The fracture surfaces of the matrix from the 23°C test are relatively flat and at an angle that suggests a ductile shear dominated failure process. The fracture surface of the matrix material in the 815°C test indicates a ductile necking type of failure.
